# PROBLEM NO. NRC-1

**Title:** Quantifying Corrosion in Fuselage Lap Joints

(1) To show examples of the type of damage that can be present in corroded 2024-T3 lap joints and (2) to illustrate the process for determining the equivalent initial flaw sizes for corroded fuselage lap joints.

*Type of Structure:* Fuselage lap joints

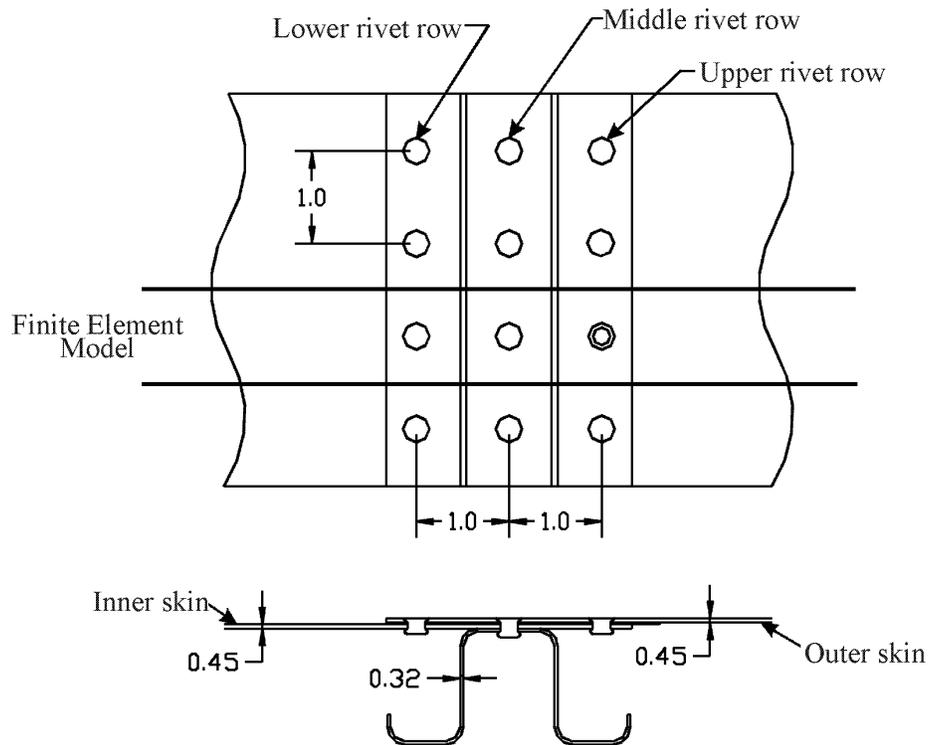
**Figure NRC-1.1.** Typical Fuselage Lap Joint

This problem focuses on one of the critical areas in transport aircraft, lap joints, which can be of various designs usually consisting of two or more layers of material with two or three rows of rivets, [Figure NRC-1.1](#). These joints are known to be susceptible to crevice corrosion, which is a form of attack that occurs when a corrosive liquid gains access to crevices in, or between components. Studies have shown that the corrosion products which form in lap joints fabricated from clad 2024-T3 aluminum material have a molecular volume of approximately 6.5 times greater than the aluminum alloy from which it originated (Bellinger et al., 1994). This increase in volume causes the skins between the rivets to bulge, an effect referred to as pillowing, [Figure NRC-1.2](#), and is often used by inspectors to identify areas in lap joints affected by corrosion.

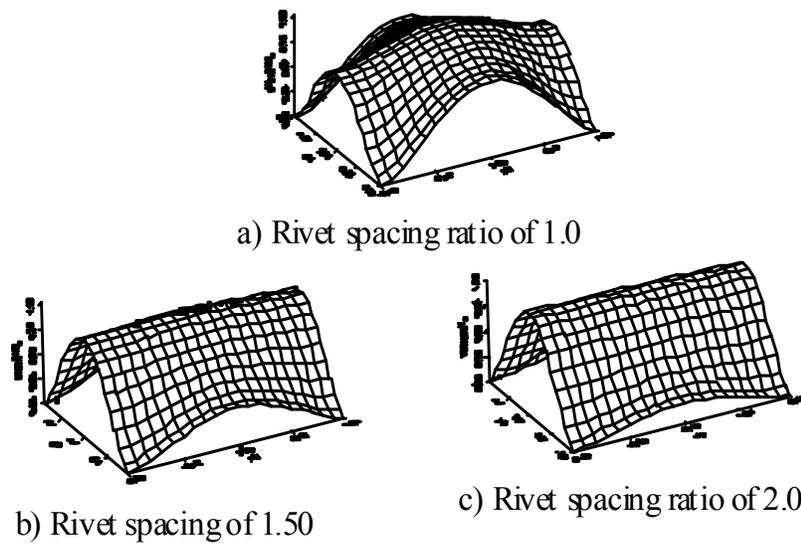
**Figure NRC-1.2.** Effect Of Rivet Spacing on Pillowing in Lap Joints

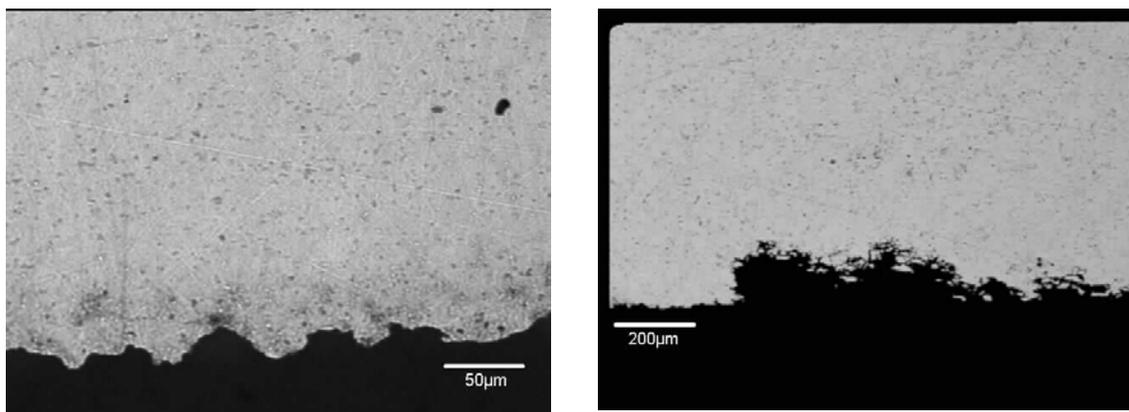
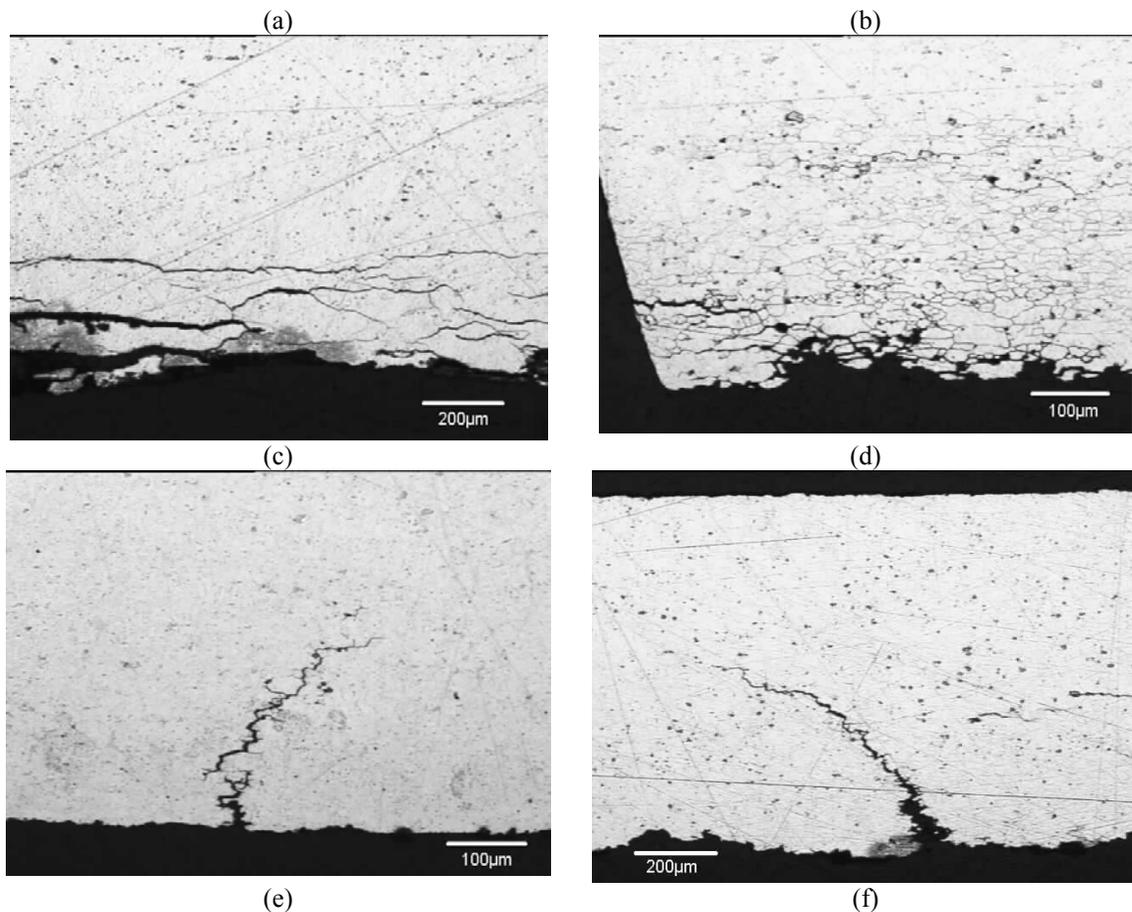
**Figure NRC-1.3.** Examples of damage present in corroded lap joints; (a), (b) pitting, (c) exfoliation along faying surface, (d) intergranular corrosion and (e), (f) environmentally assisted cracking that occurred near the rivet holes

Damage characterization studies that were carried out on naturally corroded lap joints have shown the presence of corrosion pits, exfoliation, intergranular corrosion and environmentally assisted cracking, which occurred in the presence of a sustained stress caused by corrosion pillowing, [Figure NRC-1.3](#) (Bellinger et al., 1999). It should be noted that very few “large” pits were found in the lap joints that were studied although some areas had an average thickness loss of 20% or higher. Those large pits that were found occurred in an area that contained very little corrosion damage other than the pit. The presence of intergranular corrosion and exfoliation may explain why there were very few large pits given the high thickness loss. As the intergranular corrosion or exfoliation progressed causing pits to link-up to other edges, the material between the pits could be removed by way of flaking or dissolution decreasing the existing pit depths. This, in turn would cause the remaining damage to appear less severe although the average thickness loss would be higher.

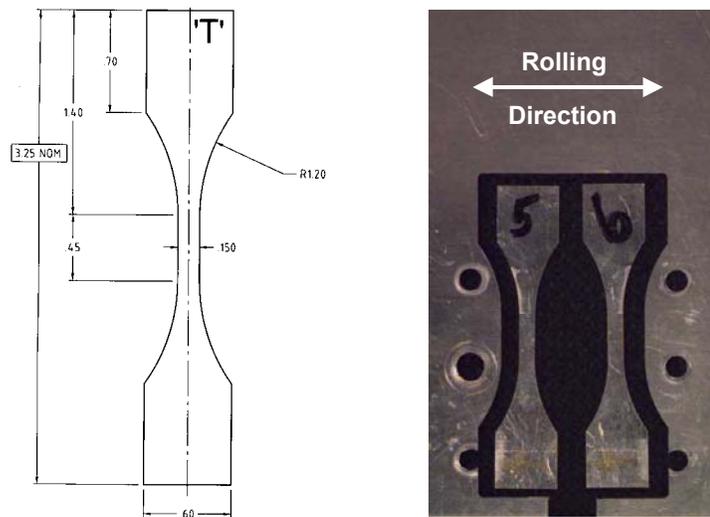
**Figure NRC-1.4.** Schematic Showing Test Coupon Configuration And Photograph Showing Orientation In Lap Joint Used For This Problem.

One of the main problems in generating ECD values is the design of the test coupon since the majority of the lap joints consist of 2024-T3 clad aluminum material, 1.27 mm (0.05 inch) thick. The ASTM E466-96 standard was used to design a coupon since it did not place any restriction on the specimen dimensions. The coupons were machined such that the loading axis was perpendicular to the material rolling direction as shown in [Figure NRC-1.4](#).

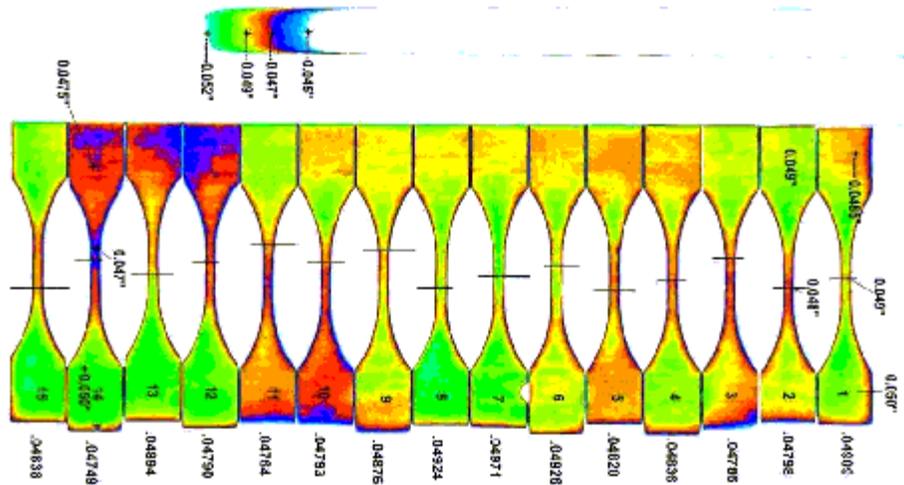
**Figure NRC-1.5.** X-Ray Thickness Maps Of Naturally Corroded Coupons

Using thickness maps developed from radiographs of the coupons, the thickness in the gauge length of each coupon was determined. Based on these results, ten coupons from the naturally corroded skins and twenty from the artificially corroded ones were machined such that the average thickness loss in the gauge length was approximately 2%. Coupons were also machined from both the naturally and artificially corroded skins so that the average thickness loss within the gauge length was 5%. [Figure NRC-1.5](#) shows the x-ray thickness maps for the coupons fabricated from the naturally corroded lap joints.
